Pacific Gas and Electric Company

PG&E Letter DCL-97-152

Docket No. 50-323, OL-DPR-82
Diablo Canyon Unit 2
Licensee Event Report 2-97-003-01
Manual Reactor Trip on Loss of Normal Feedwater Due to Unknown
Condensate/Feedwater Transient

LICENSEE EVENT REPORT (LER)

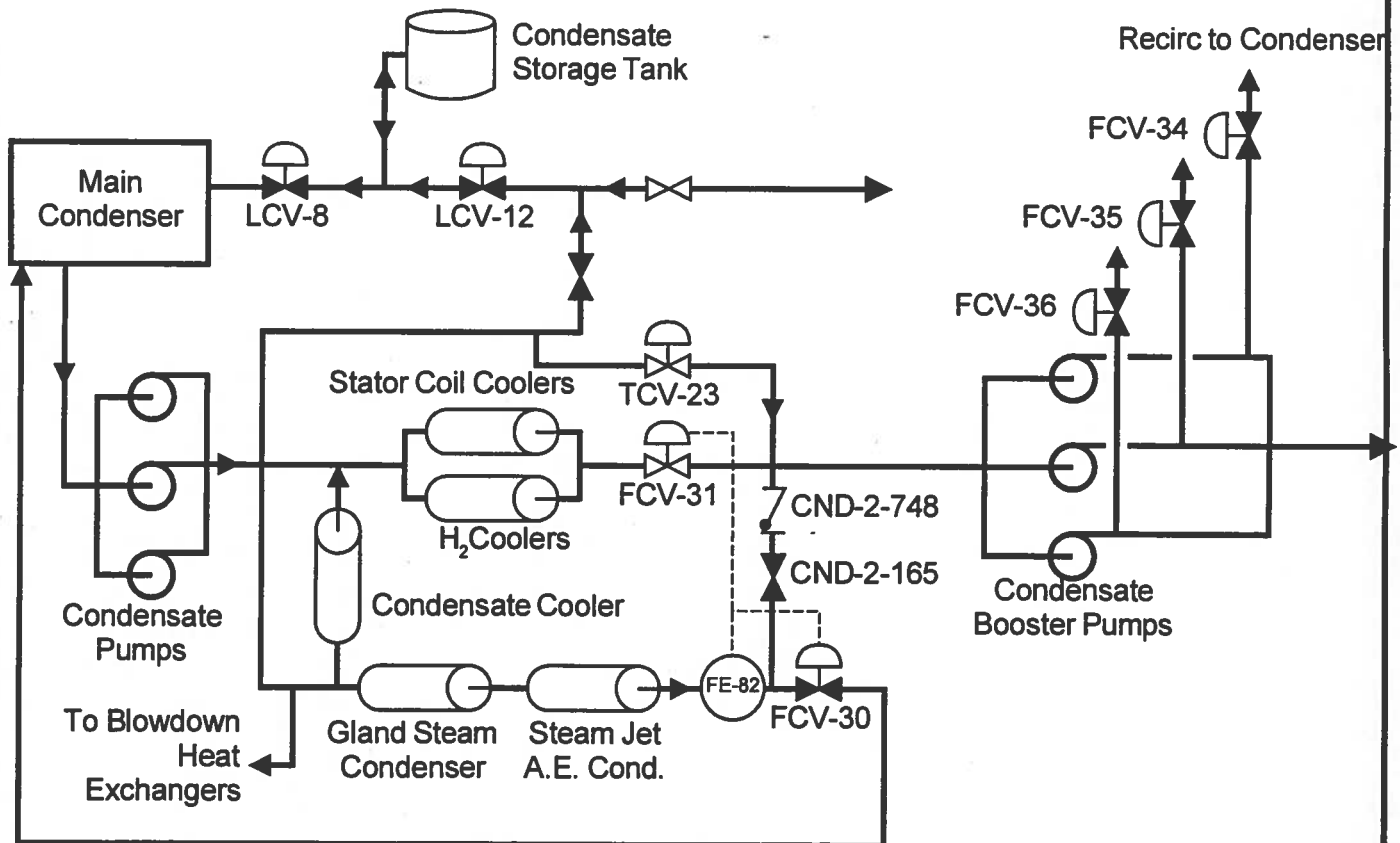
CONDENSATE SYSTEM

The condensate system [SD] provides suction to the MFWPs, as well as cooling to the main turbine generator (TG) coolers, the gland steam condenser (GSC), and steam jet air ejector (SJAЕ) condensers. A flow bypass line balances the system in response to the TG hydrogen cooling gas temperature, GSC and SJAЕ flow demand, and main feedwater (MFW) requirements (see attached "Condensate System" diagram).

Condensate pump discharge flow is distributed between the three parallel major flow paths and is controlled by three valves. The primary flow control is provided by a temperature control valve (TCV-23) in the bypass line, which reacts to TG hydrogen cooling gas temperature inputs. The secondary flow control is provided by a flow control valve (FCV-31) that responds to maintain a nearly constant GSC and SJAЕ condenser flow. The third valve (FCV-30) opens to maintain a minimum GSC and SJAЕ flow.
